# **Dam Safety Assessment of CCW Impoundments**

## **Kincaid Generation – Slag Field**

**United States Environmental Protection Agency  
Washington, DC**

March 24, 2011

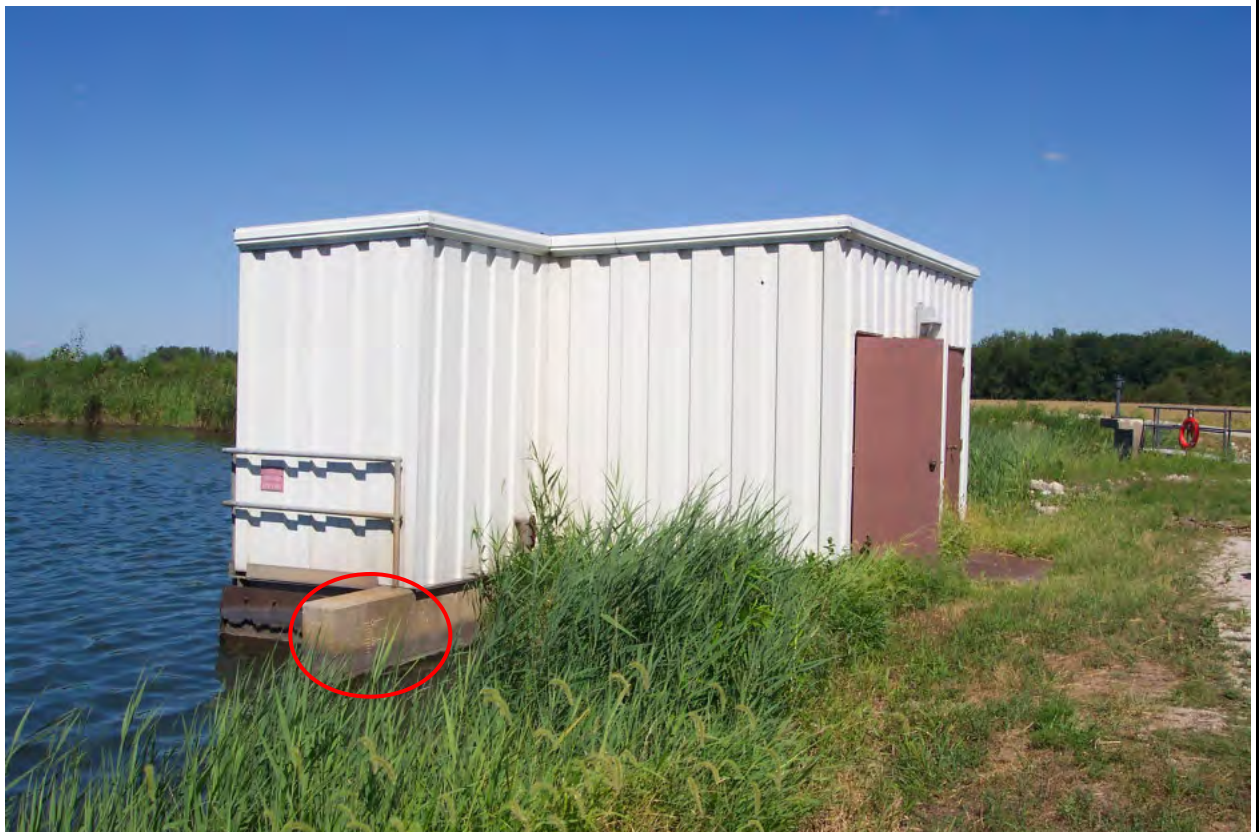
Photo Number:  
2

Instrumentation is present at one location at the Slag Field impoundment. This instrumentation consists of gauge markings on the screen house foundation to monitor pool elevation. This level is observed and recorded three times daily (once per shift). (Appendix B – Photo 2)

Description:  
View of screen  
house for  
recycle intake.

Note gage  
markings on  
building  
foundation.  
This level  
observed/  
recorded  
multiple times  
daily.

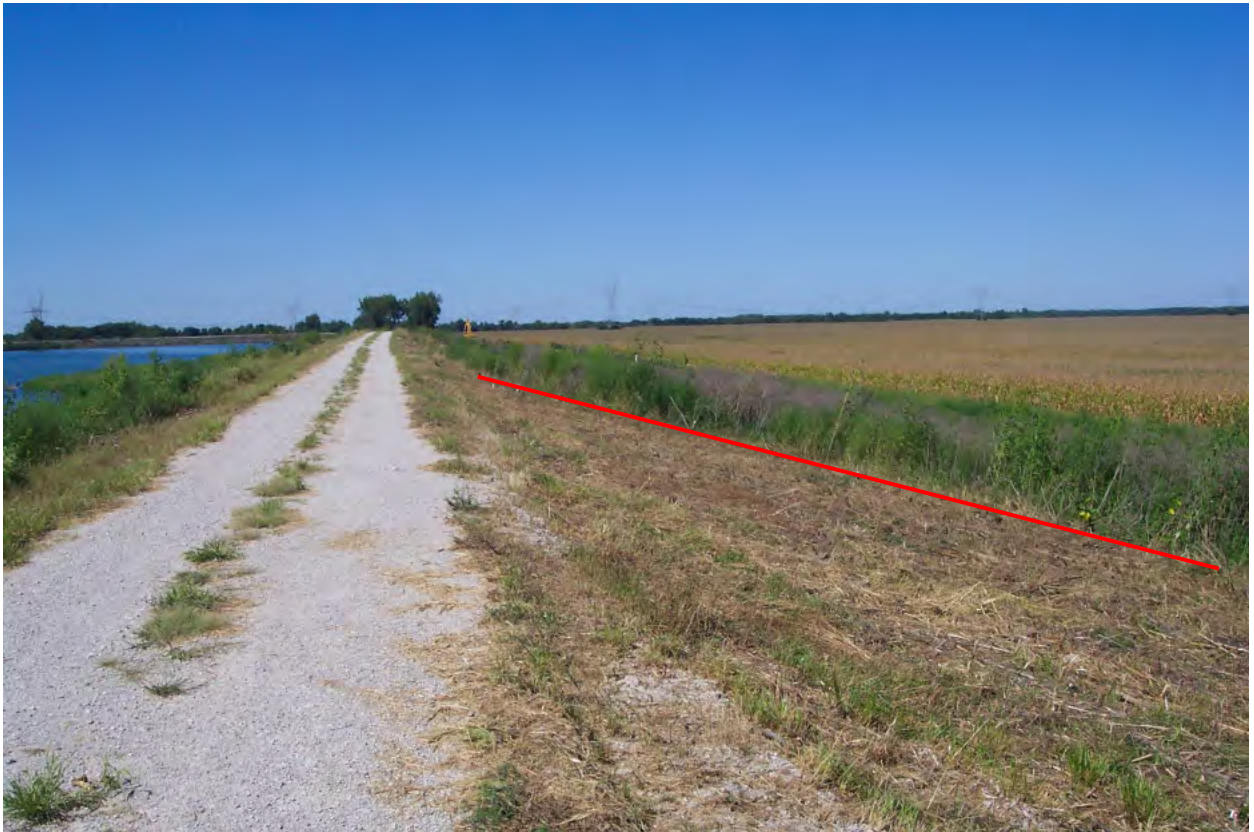
Photo Number:  
5

Description:  
View along  
crest of east  
embankment

Note condition  
of mowed area  
versus not  
mowed area

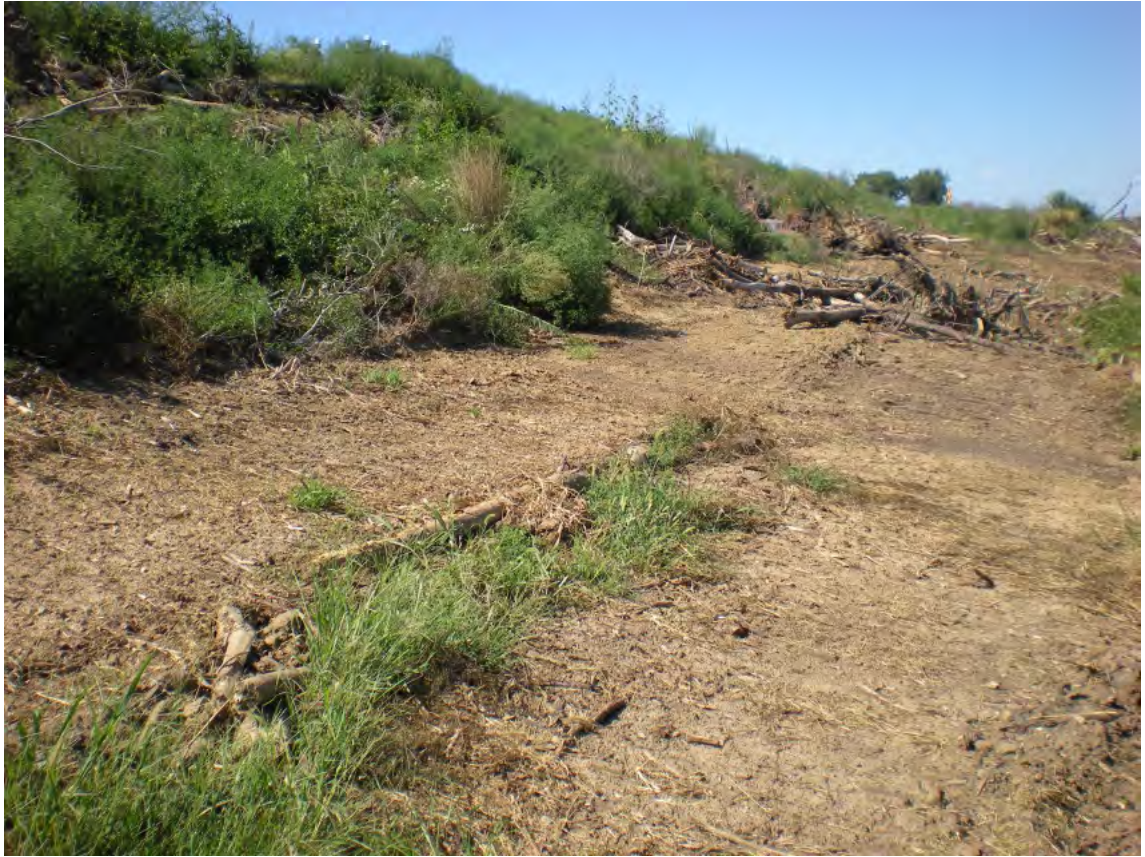
Photo Number:  
7

- Existing stumps were observed in place along the eastern portion of the north embankment. (Appendix B – Photo 10)
- Stump remnants and woody debris remained along a significant portion of the east embankment from the ongoing clearing activities. Surface vegetation was also missing in these areas with much of the area in need of surface grading. (Appendix B – Photos 7 & 8)

Description:  
View of east  
embankment  
from toe of  
embankment.

Note g  
rubbing  
in progress and  
size of  
trees/brush  
removed.

Dominion has reported that the stump removal and regrading of the north and east embankments was completed as of October 18, 2010. Reseeding was conducted in December 2010. Following these efforts vegetation establishment is planned for completion by June 2011. O'Brien & Gere recommends that Dominion continue as planned to fully establish and manage the vegetated cover of these embankments.

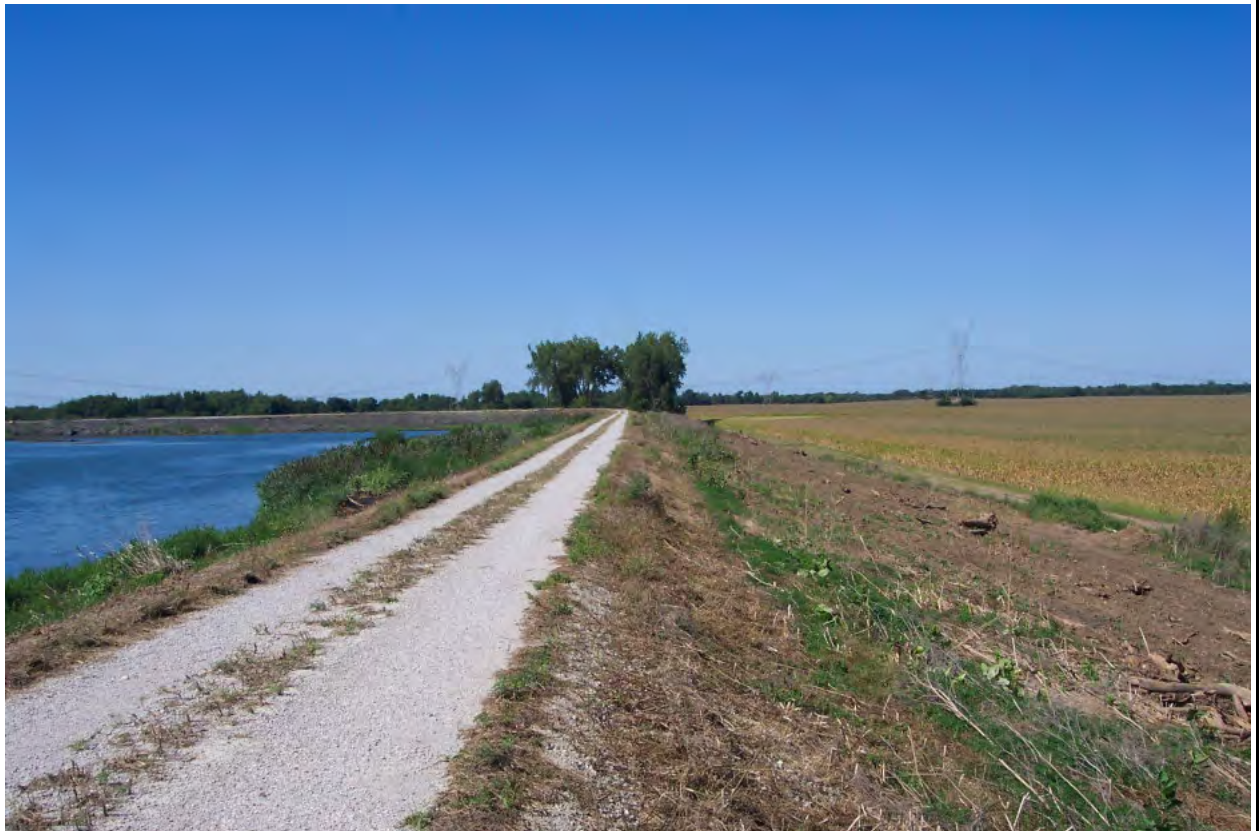
Photo Number:  
8

Description:  
View along  
crest of east  
embankment.

Note condition  
of downstream  
embankment  
slope where  
grubbing has  
been recently  
completed

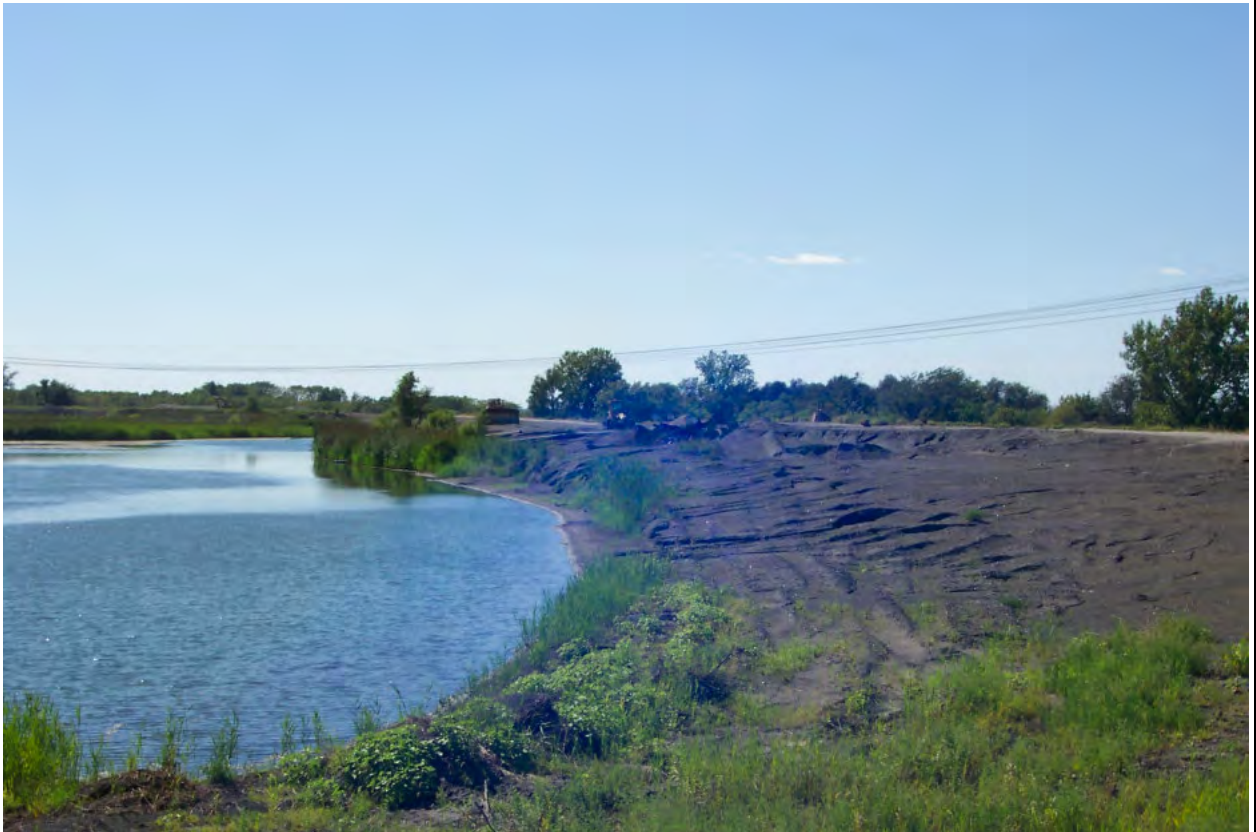
Photo Number:  
9

- The placement and grading of non-recyclable slag along the upstream slope of the north embankment was observed in progress. (Appendix B – Photos 9 & 12)

Description:  
View along  
interior side of  
north  
embankment

Note placement  
of reject slag in  
progress by  
contracted  
recycling  
company.

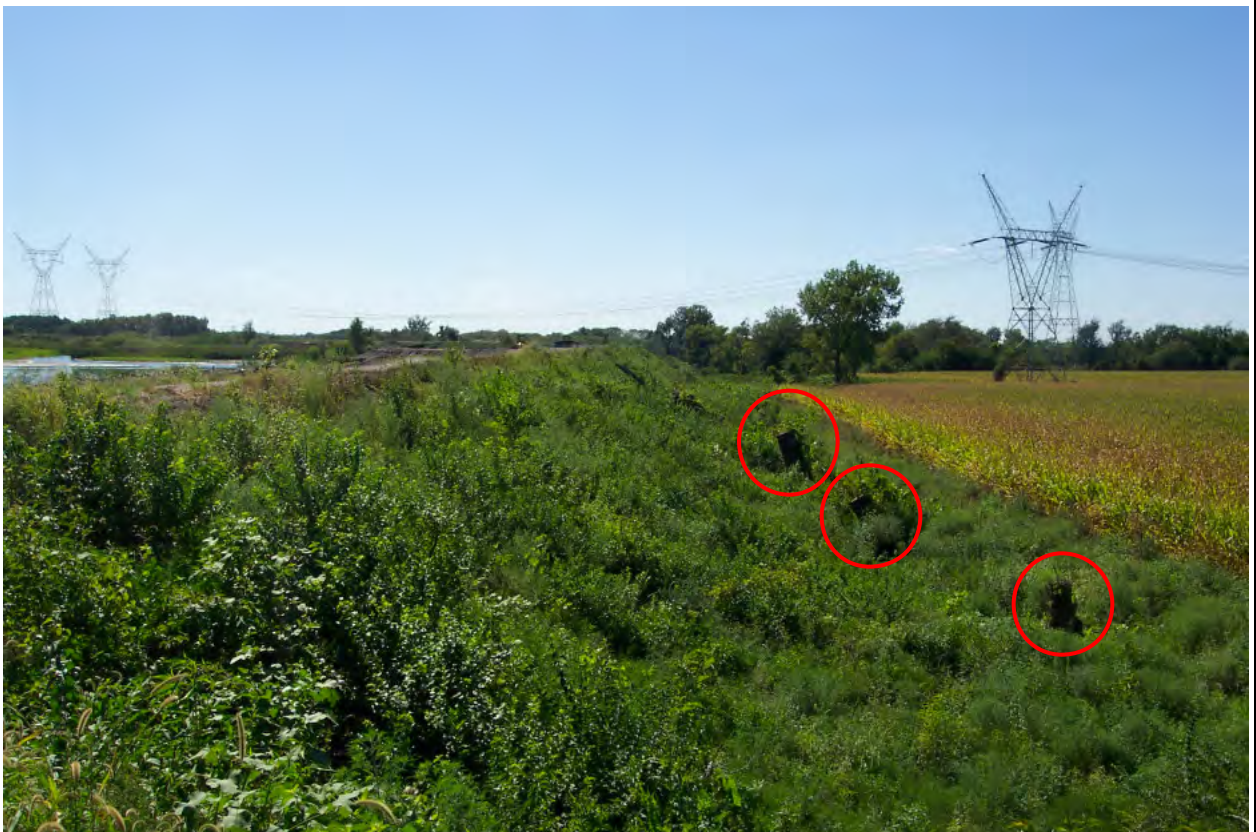
Photo Number:  
10

Description:  
View along  
exterior side of  
north  
embankment

Note trees have  
been cut and  
grubbing/stump  
removal to be  
completed

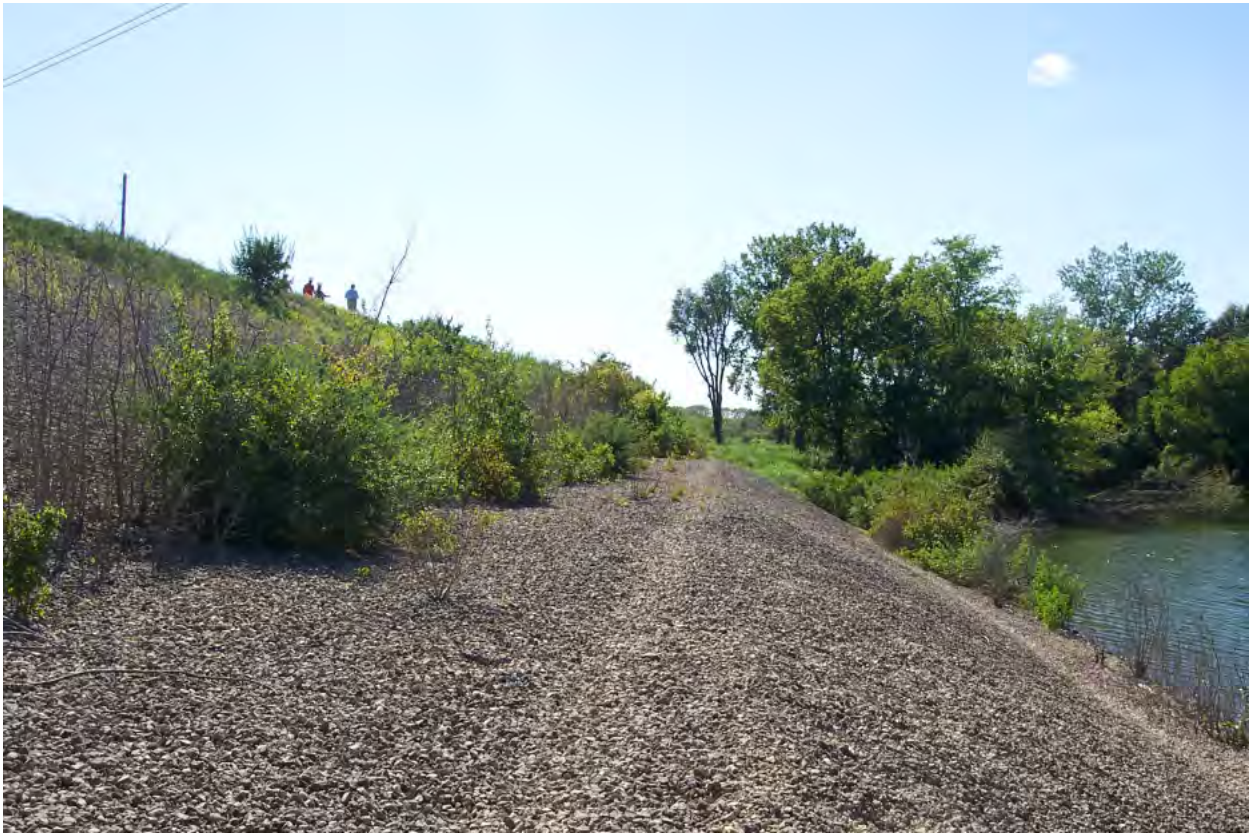
Photo Number:  
11

- In the mid 1980's a portion of the north embankment which is adjacent to Lake Sangchris was repaired for erosion protection purposes. The existing condition is a benched embankment with a coarse aggregate cover. Plans or engineering documents for this repair were not available for review. (Appendix B – Photo 11)

Description:  
View along  
section of north  
embankment,  
area repaired to  
protect against  
wave erosion in  
1980's

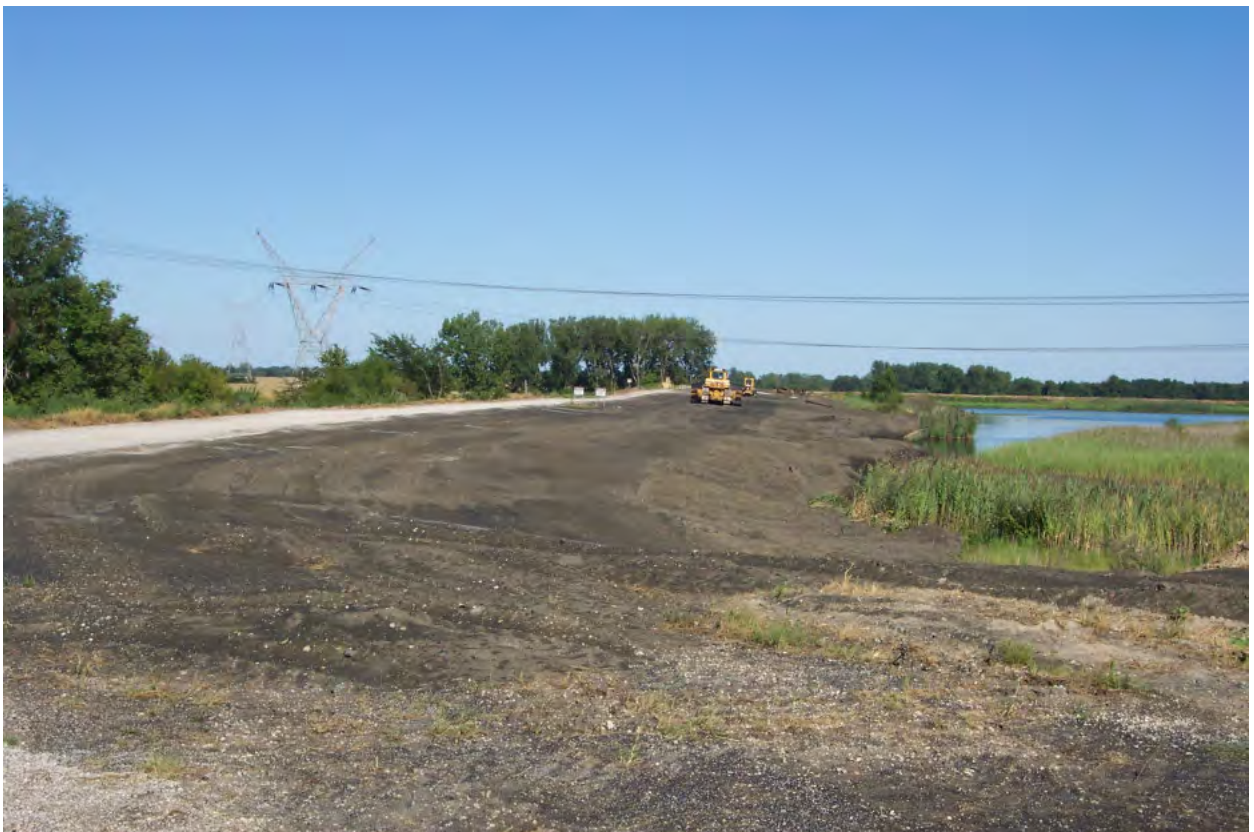
Photo Number:  
12

Description:  
View along  
interior side of  
north  
embankment

Note placement  
of reject slag in  
progress by  
contracted  
recycling  
company.

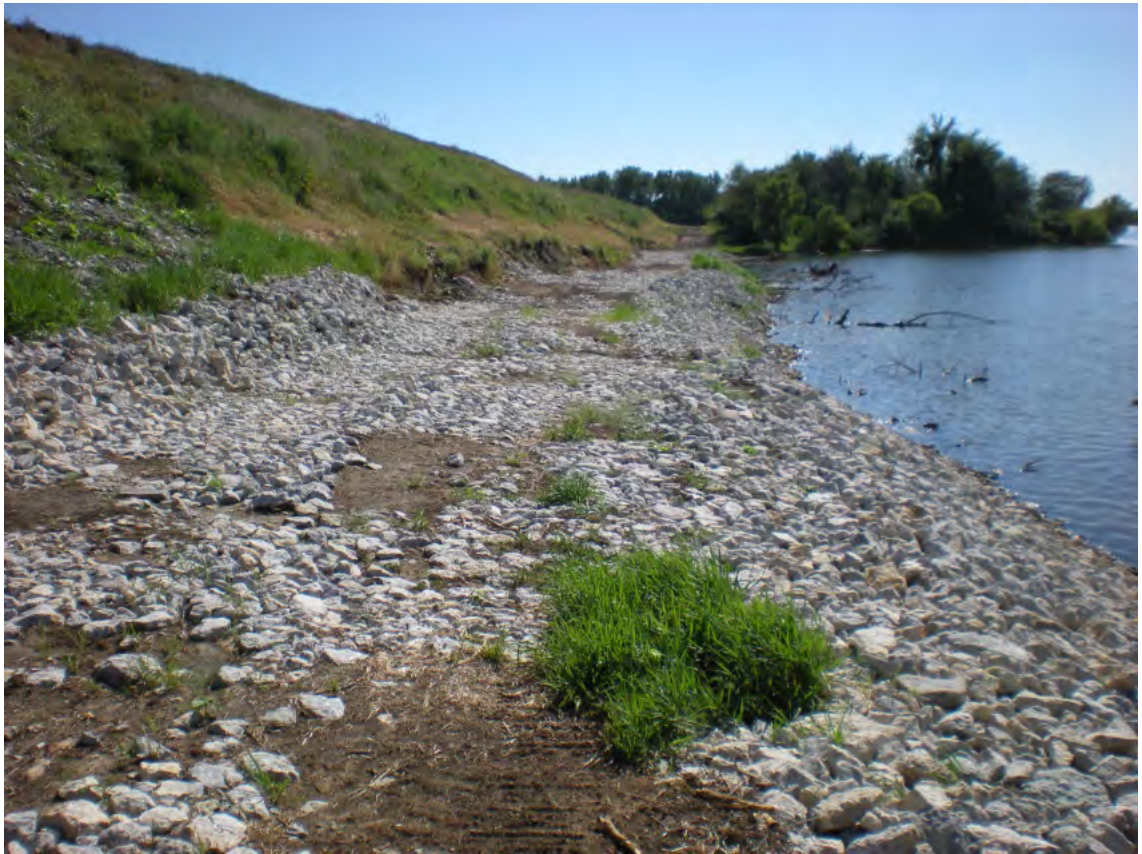
Photo Number:  
13

- Earlier in 2010, rip-rap armoring was undertaken along the downstream toe of the northwest embankment to repair and protect this area from wave erosion from the lake. This effort is approximately 75% complete with minor regrading items remaining. (Appendix B – Photos 13 & 14)

- The rip-rap placement on the northwest embankment was observed to be nearly complete. (Appendix B – Photos 13 & 14)
- A large percentage of the western half of the impoundment was observed to be permanently filled with slag.

Description:  
View along toe  
of northwest  
embankment

Note rip rap  
erosion  
protection  
placement in  
progress

- 1) Continue rip-rap repair of wave eroded toe of northwest embankment
- 2) Continue tree removal/regarding efforts along east and north embankments

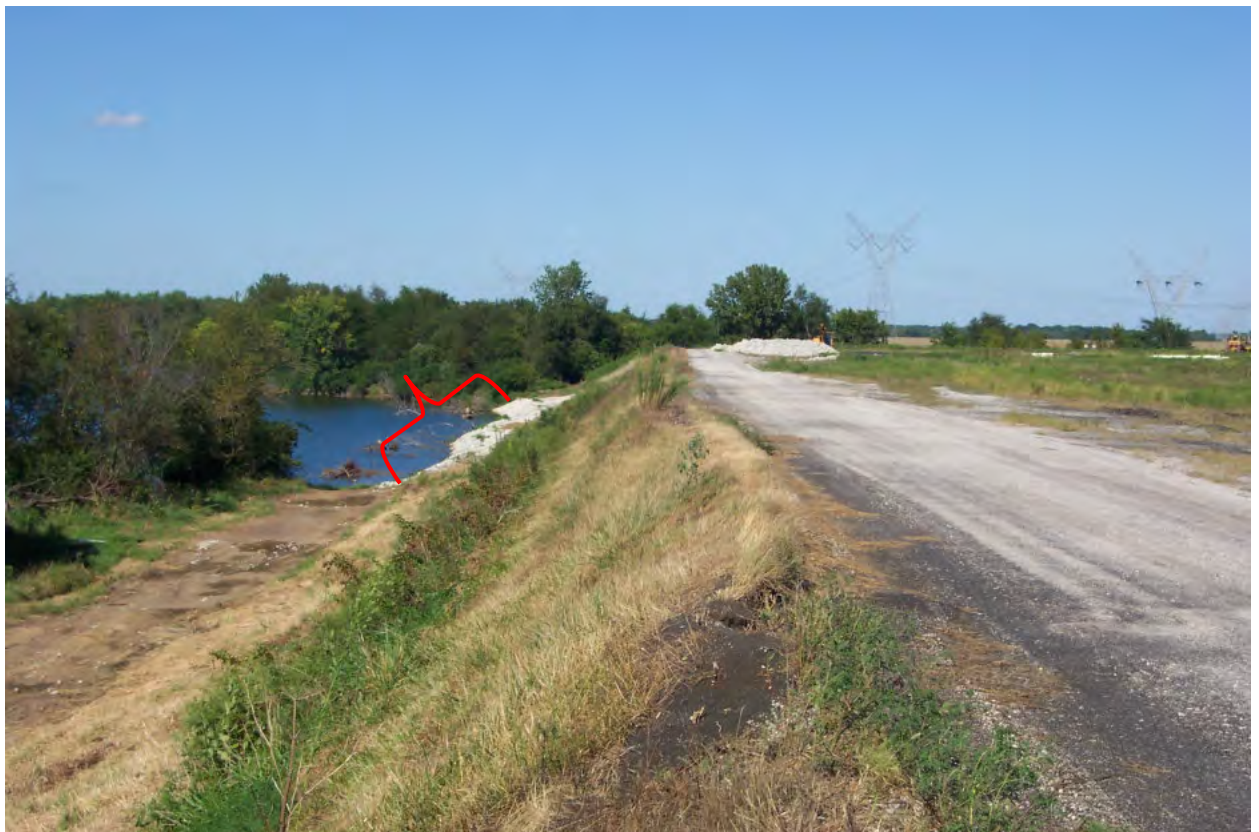
Photo Number:  
14

Description:  
View along  
crest of  
northwest  
embankment

Note rip rap  
erosion  
protection  
placement in  
progress at toe  
of exterior  
slope

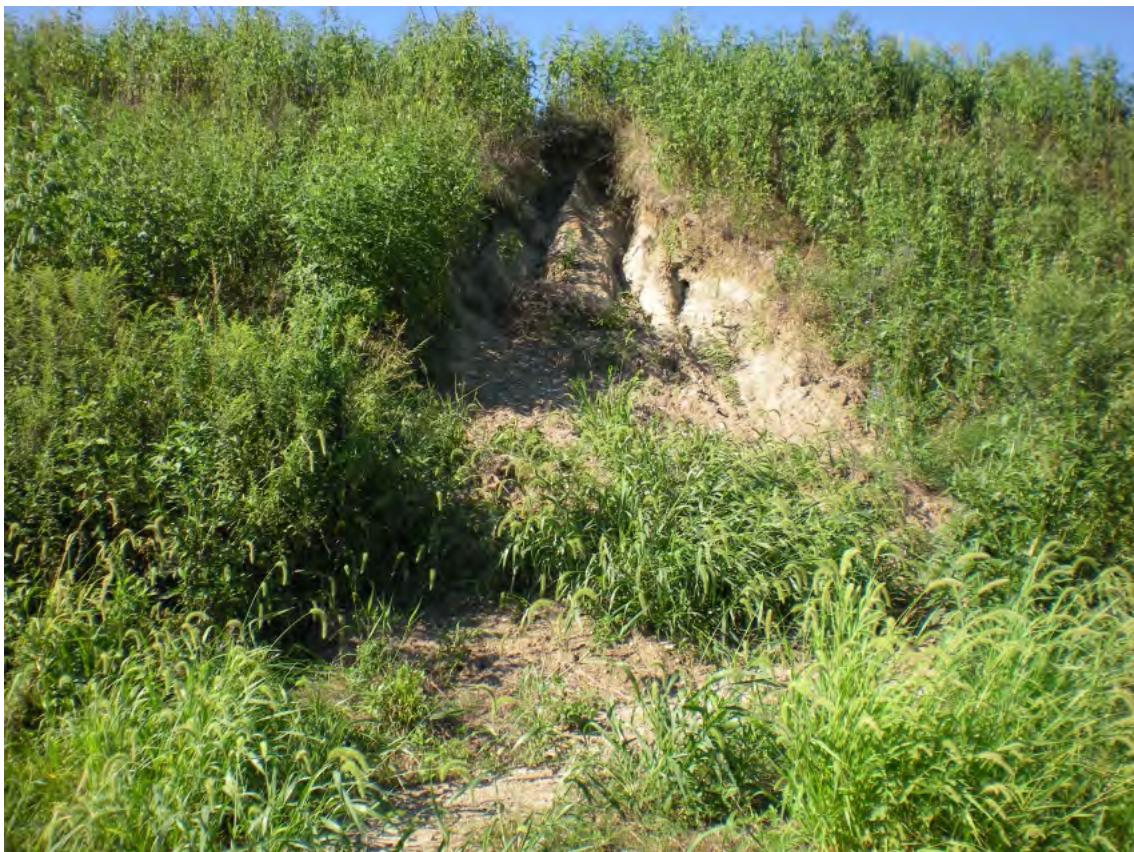
Photo Number:  
18

- Erosion of the slope was observed at the western portion of the south embankment. (Appendix B – Photo 18)
- Minor gully erosion was observed in the downstream slope where the north portion of southwestern embankment meets the western embankment.

Description:  
View of eroded  
slope from toe  
on west portion  
of south  
embankment

- The slope erosion observed at the western portion of the south embankment should be repaired
- Completion of the rip-rap reinforcement project should continue as planned
- Completion of the stump removal, regrading and vegetation establishment should continue as planned
- Record drawings of work conducted should be completed/remain on file

Dominion has reported that the repair of the slope erosion in the western portion of the south embankment was completed as of October 19, 2010.

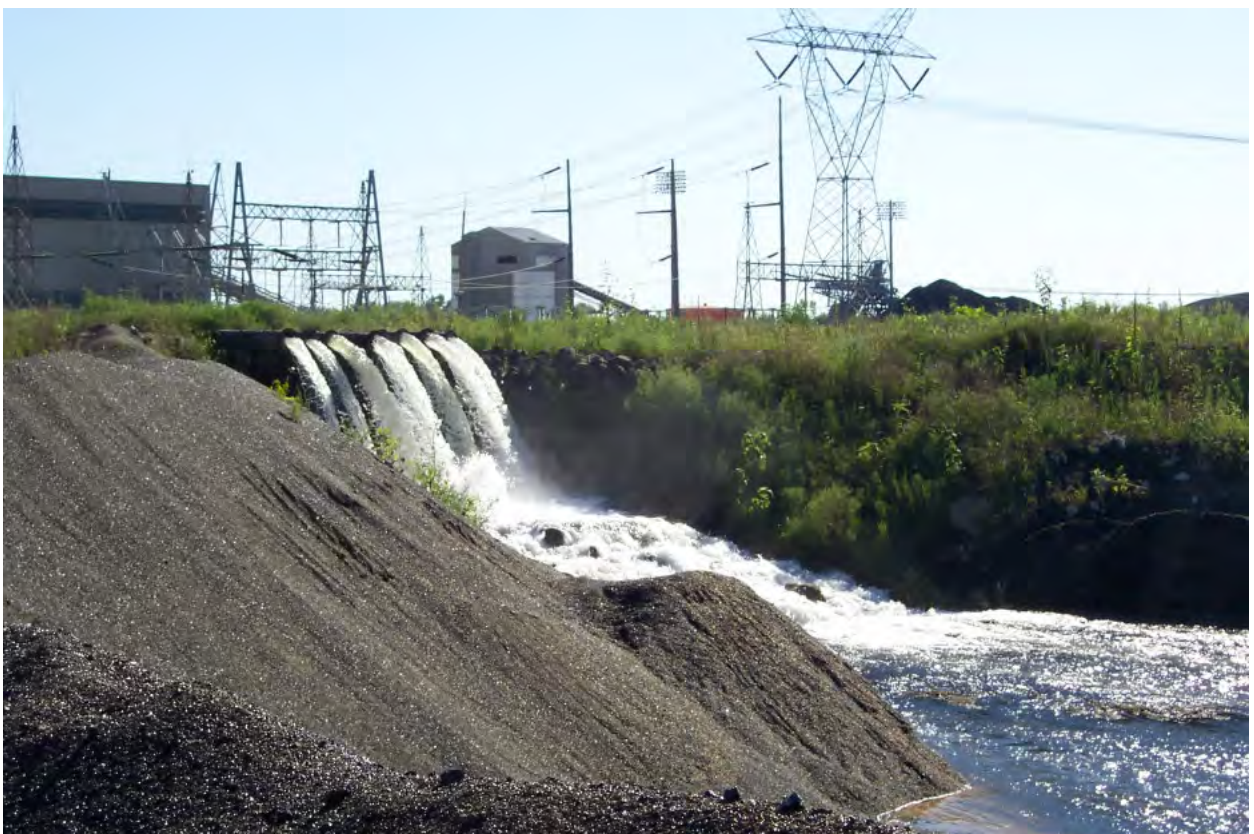
Photo Number:  
20

- Over time, the inlet piping has been changed to various configurations (i.e, lengthened, shortened, rerouted to different locations, etc.) Details of these variations were not provided. As observed during this inspection, the inlet piping consisted of eight open discharge pipes which discharge slag and water onto a rock reinforced area (Appendix B – Photo 20).

- The Slag Field was observed in normal operation at the time of the visual inspection with the water level in the pond observed near its typical level. Water was observed flowing freely into the impoundment at the inlet piping and flowing freely out of the impoundment into the screen house chamber. (Appendix B – Photo 20)

Description:  
View of  
discharge piping  
and flow into  
slag field
